## HHSRS DEFECT HIGHLIGHT REPORT

HHSRS Hazard 1: Damp and mould growth | Awaab's Law: Phase 1 — LIVE | EMERGENCY — 24-hour duty in force now

| Property Address | Greek Street, Stockport, SK8 9JS | Report Reference | R26-433 |

#### 2.1 Defect 01 — Damp and mould growth

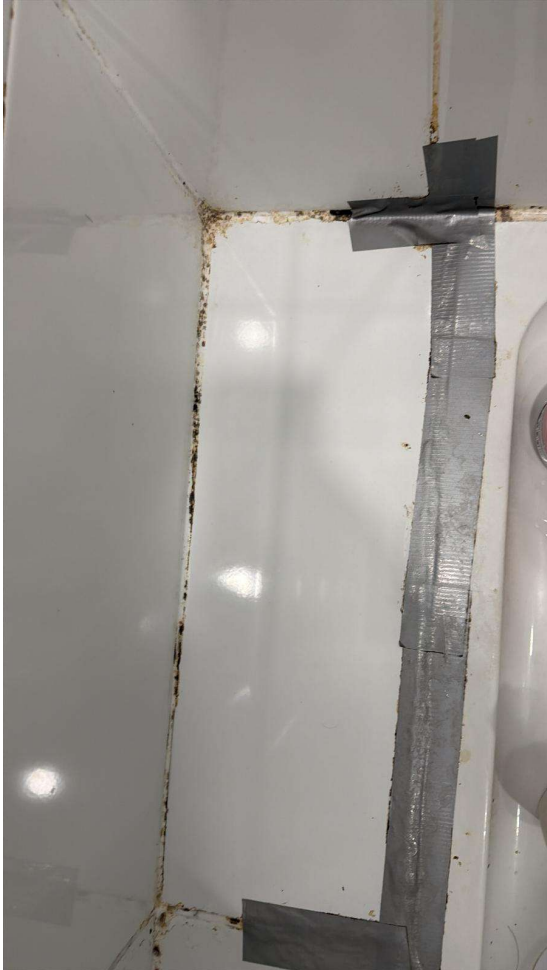
| Category | <b>CATEGORY 1 — Not formally HHSRS-scored. Significant risk of harm to occupant confirmed.</b> |
|---|---|
| <b>Observation</b> | Photograph 1 documents extensive black mould growth along tile grout joints and panel edges within the shower enclosure corner. The mould colonies are visually consistent in appearance with <i>Stachybotrys chartarum</i> or <i>Cladosporium</i> species, both of which are commonly associated with persistently damp internal environments. Formal microbiological identification would require laboratory analysis of surface swabs or air samples, which has not been undertaken as part of this instruction. |
| <b>Root Cause</b> | Chronic moisture ingress through failed grout and sealant joints in wet area; Inadequate or non-functional bathroom ventilation (insufficient air changes per hour per BS 5250); Cold bridging at ceiling-wall junction promoting condensation on cold surfaces. |

**PHOTO 01:** The photograph shows a bathroom or wet room corner with extensive black mould growth along tile grout joints and panel edges, combined with heavily deteriorated and failed grout/sealant. Duct tape has been applied as a makeshift repair to the panel joint, indicating a known water ingress or movement issue that has not been properly addressed. The mould coverage across multiple grout lines and the corner junction is substantial, likely exceeding 0.25 m<sup>2</sup>, and represents a significant health hazard under HHSRS. The improvised repair with duct tape is not a compliant or durable waterproofing solution and will be contributing to ongoing moisture ingress.

| # | REQUIRED ACTION | PRIORITY | RESPONSIBLE PARTY | TIMESCALE | AWAAB'S COMPLIANCE |
|---|---|---|---|---|---|
| 1 | Remove all failed grout and sealant throughout the wet area and regROUT/reseal with a proprietary epoxy or anti-fungal grout and sanitary-grade silicone sealant to BS 5385. | URGENT | Maintenance Team | 5 working days | Phase 1 |

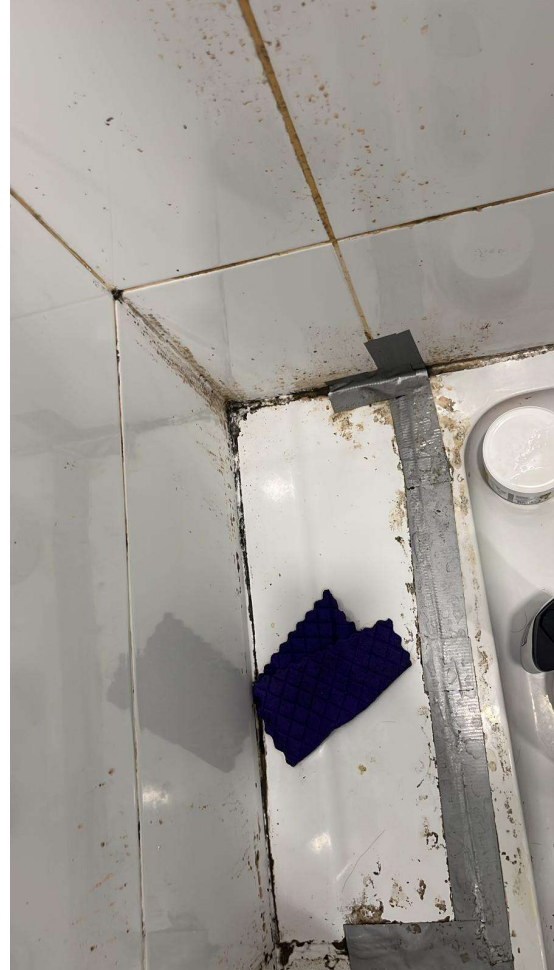
**PHOTO 02:** The photograph shows a shower enclosure in a UK social housing property with extensive black mould growth across wall tiles, ceiling tiles and grout joints, consistent with a longstanding damp and mould hazard under HHSRS Hazard 1. The affected area appears to exceed 0.25 m<sup>2</sup> and covers multiple surfaces including the ceiling plane, which significantly elevates the health risk to occupants. Grout joints are heavily colonised and there is widespread brown organic staining across tile faces. A strip of duct tape has been applied to the shower tray surround, suggesting a prior attempted repair to a leaking seal which may be a contributing moisture source.

| # | REQUIRED ACTION | PRIORITY | RESPONSIBLE PARTY | TIMESCALE | AWAAB'S COMPLIANCE |
|---|---|---|---|---|---|
| 2 | Inspect and test the bathroom mechanical extract ventilation (MEV) unit or extractor fan — verify it meets minimum 15 l/s (54 m³/hr) intermittent extract rate for bathrooms per Building Regulations Part F and BS 5250. | URGENT | Maintenance Team | 5 working days | Phase 1 investigation |
